NEW JERSEY EXECUTIVE STATEHOUSE

SUMMARY LETTER

25 JANUARY 2017

In January 2013, H2L2 Architects and Planners - now **NELSON** – in association with **Preservation Design Partnership, LLC [PDP]** were selected to provide architectural and engineering services for the Restoration of the Exterior Building Envelope of the New Jersey Executive State House [**NJESH / DPMC Project No A 1150.00**].

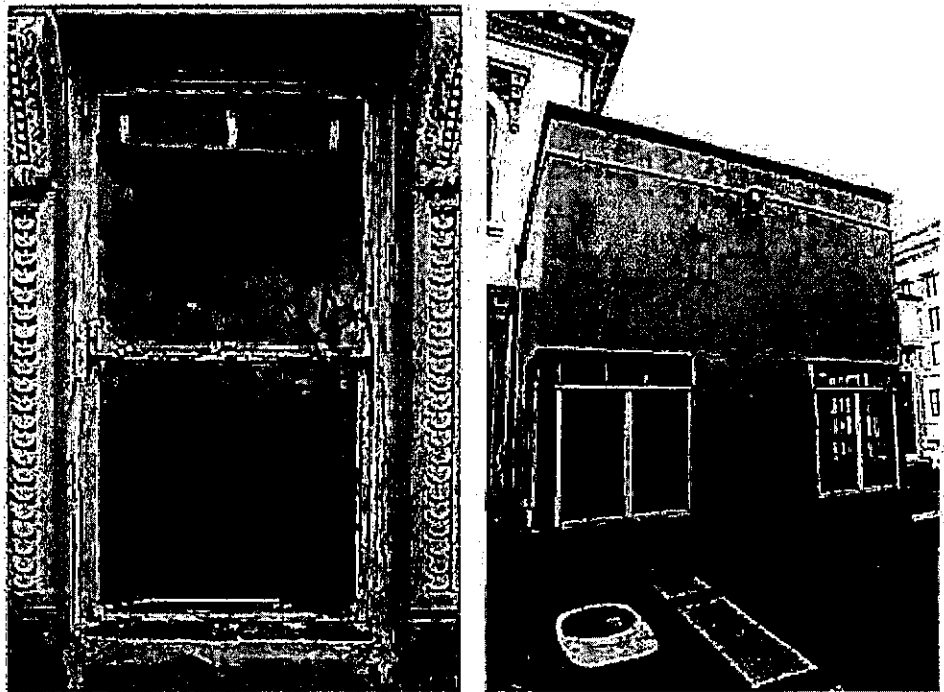
Existing Window.

Cracks at Governor's Suite Offices.

- The office additions next to the Governor's Office were constructed in 1944, 1947 and 1958. Our survey confirmed that the walls of these additions bear solely on the roof structure and do not align with the structural beams and columns below but are supported on the concrete roof joists. The existing concrete joists were not designed for this additional load. The observed cracking of the masonry is a reflection of several issues, including:
 - a. Water infiltration from the roof and roof parapet
 - b. Water infiltration at cracks in masonry wall
 - c. Poor masonry work of the wall construction
 - d. Deflection of the lightwell roof joists due to loading
 - e. Deflection of the lightwell roof joists due to long term concrete creep. Creep is deflection under sustained load where long term pressure on the concrete can make it change shape.

Shoring will be installed to provide a short term solution until a permanent structural repair is made.

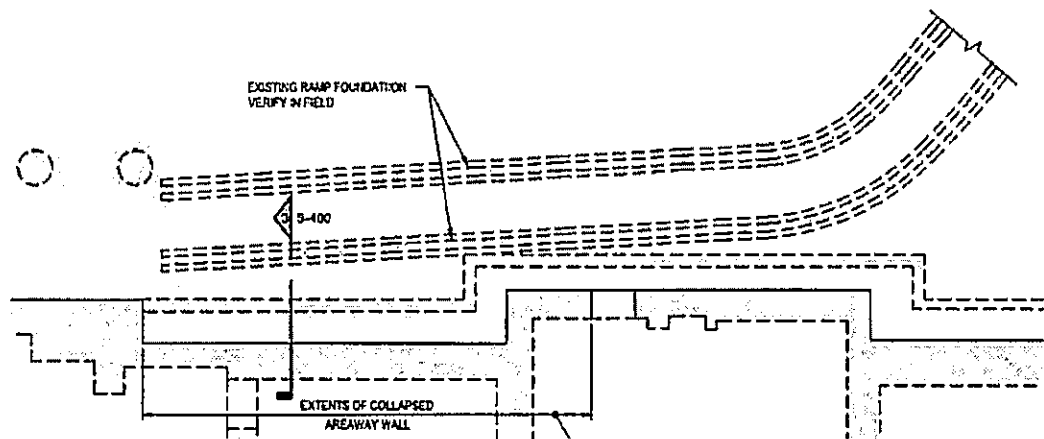
- The basement areaways of the north section of the building, several of which have collapsed, will be stabilized. These areaway walls support the soil that is to the north of the walls, the sidewalk slab on grade to the north of the walls, and the handicapped accessibility ramps. The extent of the collapsed areaway wall is located to the east of the north building entrance. A partial plan of this area is shown below. The collapsed section of areaway supports and is directly behind landscaping and is not readily accessible to the public. The collapse appears to have been caused by the undermining of the existing footing by the ramp foundation that was installed adjacent. The areaway walls themselves are suffering deterioration from their age and lack of maintenance.

Extents of collapsed areaway wall

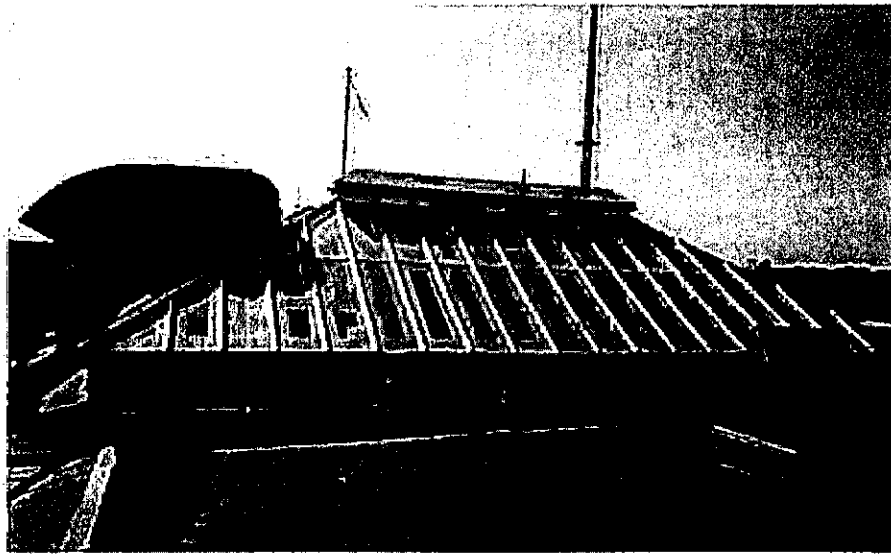
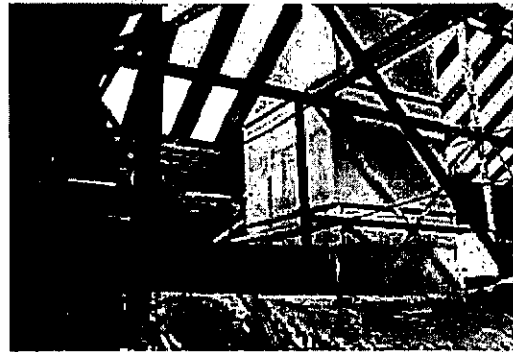
3. **Skylights:**

All skylights have severely deteriorated and corroded. Inappropriate mechanical interventions have further compromised the architectural integrity of the skylights and impacted the historic skylights

below. The skylights have far exceeded their safe and useful life and must be replaced with new assemblies, which will likely be stronger and heavier than the existing units.

Before new skylights are installed, the existing trusses will require reinforcement to support the heavier assemblies, as well as to comply with contemporary code-requirements for snow and wind loading.

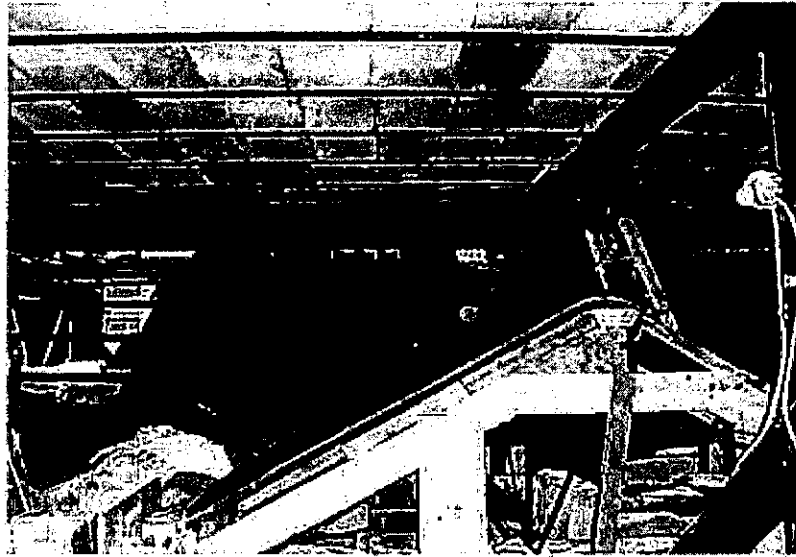
5. North Attic:

In addition to the issues associated with water infiltration, the attic is an area of significant risk. HVAC ducts have been placed throughout the attic without a logic and / or a plan, as individual projects were undertaken over the last 60 years. In addition, the presence of combustible materials - remnants of past building campaigns, i.e. old roofs, etc. - represent a significant life safety risk since there is no automatic sprinkler system providing full coverage throughout the building.

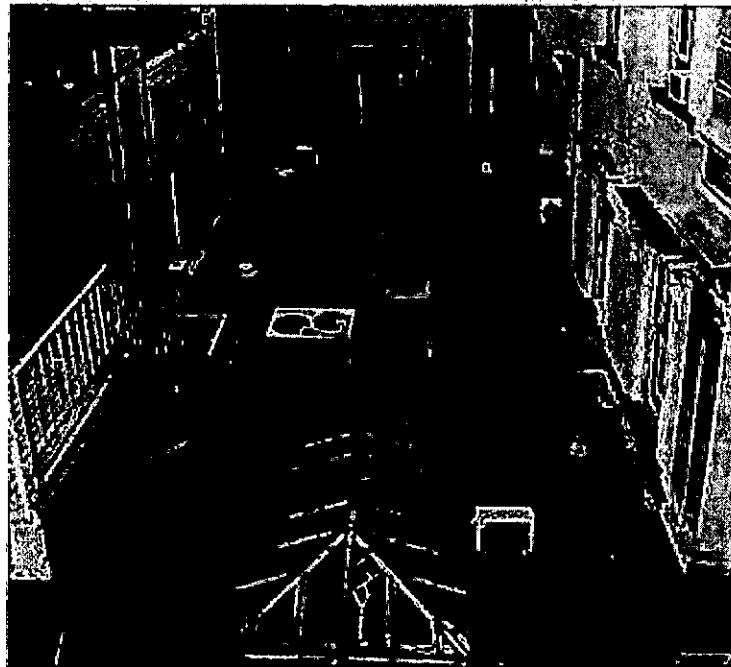
East Lightwell.

The east and west lightwells require complete replacement of the existing roofs. The issues associated with this work are as follows:

- Concrete core testing indicated that the existing concrete slabs have experienced some carbonation. Carbonation results from exposure to air and moisture and can spread over time. This causes the steel reinforcement to become more susceptible to corrosion, which can impact the slab capacity for supporting loads. [It is important to note that the slabs are already under-designed and they do not meet current code mandated load requirements]

- Finally, since lightwell structures were an "afterthought" when they were constructed in 1920 and 1944, they were placed within the available dimensional allowances in relationship to the historic window sills, which do not allow for proper flashing and transitions. Replacing the roofing systems without addressing this issue will not address the water infiltration on a long term basis.

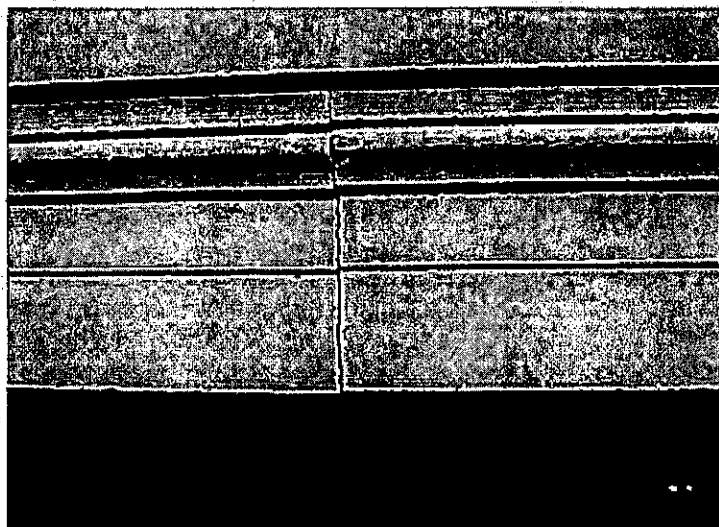
10. Window Lintels:

Several lintels throughout the building present severe deterioration, cracking and in some cases movement. Expensive repairs are required to correct this condition.
