NEW JERSEY EXECUTIVE STATEHOUSE

SUMMARY LETTER

25 JANUARY 2017

In January 2013, H2L2 Architects and Planners - now **NELSON** – in association with **Preservation Design Partnership, LLC [PDP]** were selected to provide architectural and engineering services for the Restoration of the Exterior Building Envelope of the New Jersey Executive State House [**NJESH / DPMC Project No A 1150.00**].

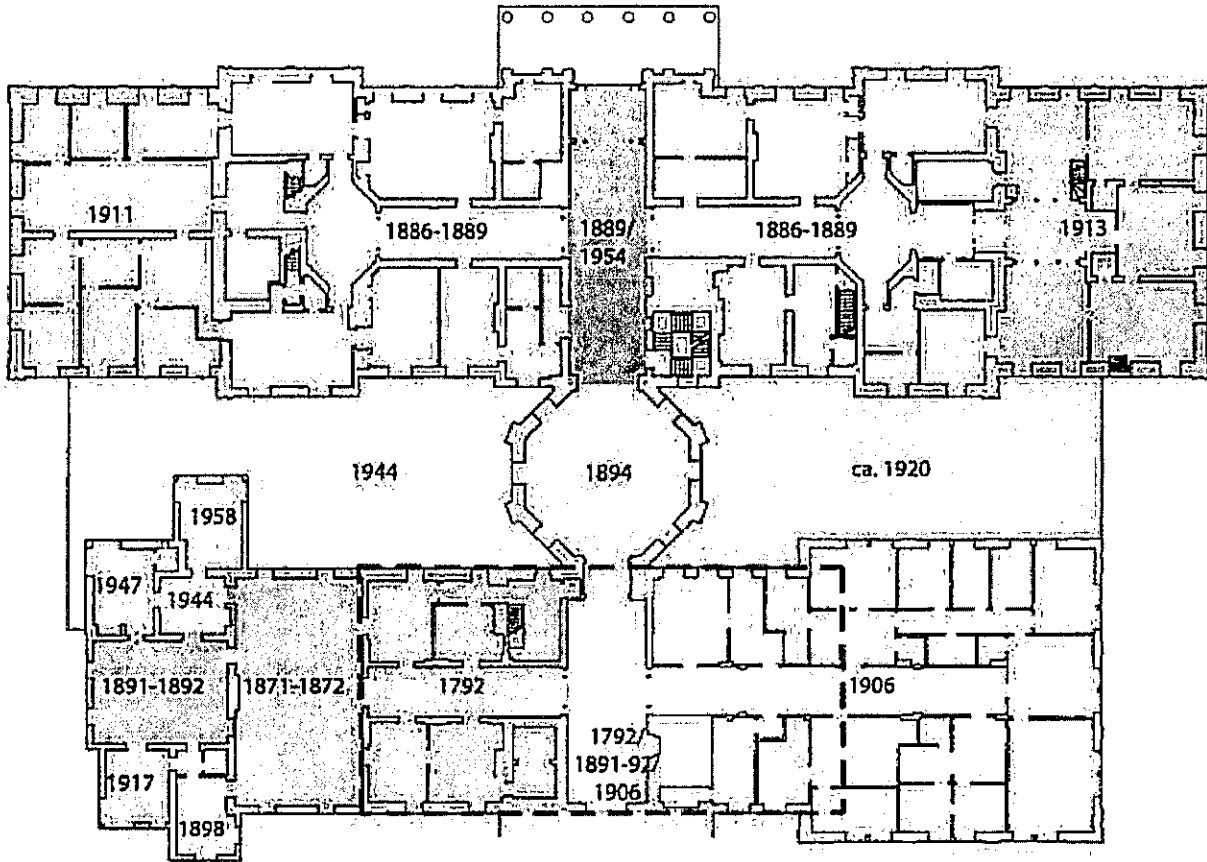
The NJESH was constructed, expanded and developed over 15 building campaigns from 1792 to 1958. It contains the oldest and most historic sections of the State House. The following diagram delineates the construction sequence of the ESH.

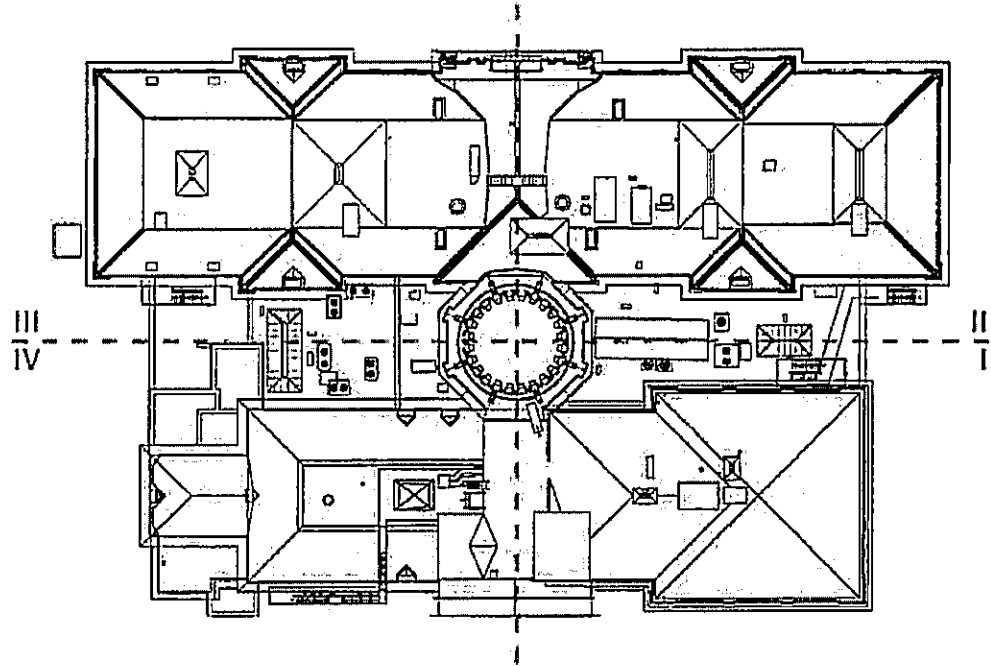
While the ESH was constructed over multiple building campaigns, its organization is simple and straightforward. Its plan is an "H", creating four quadrants, with the historic Dome and Rotunda occupying the center of the "H".
